Issue no. 66
December
1980

KR NEWSLETTER

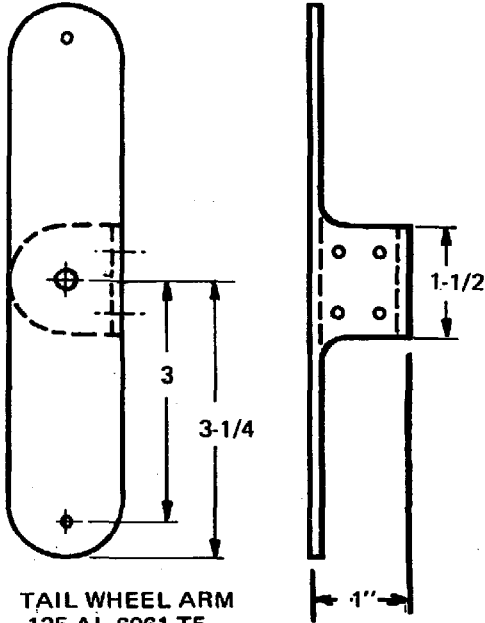
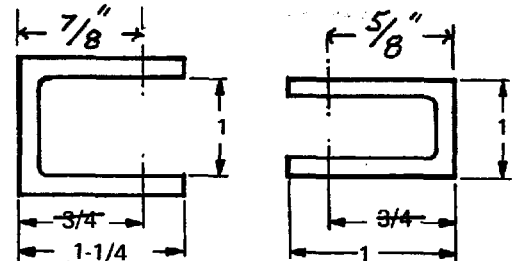
KR-2 DRAWING NO. 15

****KR-1 and -2 drawing #15 shows 2 views of the tail-wheel arm, with a notation of 3 each required. The hinge hole for rudder and elevator bellcranks must be drilled in line with the other hinges, i.e. 5/8". The holes will then be "in plane". Overall length of the bellcrank should be increased to a minimum of 6 5/8". See drawing.**
